**Flood Control Project Maintenance
Levee Inspections**

Fall 2015 Levee Maintenance Deficiency Summary Report

Sacramento River Basin

Reclamation District No. 0341 Sherman Island

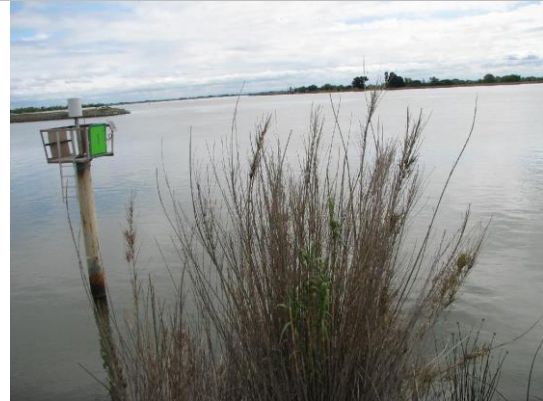
Photo 1 of 3 : UCIP_FA_2015_1748.jpg

Action/Comments					
Inspector Comments: FS_ID:22063 DS_ID:24215 EP_NO: N/A FS_HLM: 0 Repair Type: Non-Urgent Crossing Status: Found UCIP Comments: Dense vegetation limits the inspector's visibility to identify signs of pipe failure (leaks) along the slopes. Recommend removing vegetation along pipe alignment to conduct proper inspection of structure and appurtenances. FIELD_STRUCT_DESC: 30-inch steel drainage pipe through the levee, 11.1 feet below the crown. CM cutoff wall around pipe at center of levee. Siphon breaker on both sides. Pump on landward side approximately 300 feet from landward toe. Pipe exposed on both levee slopes. Rock revetment on waterward slope. (USACE-1962). This entry matches the Drainage or Irrigation Structure referenced in O&M manual (HLM 0.0). Marine Station number 1 located on waterward side with attached small solar panel on top. FS Date: 05/05/2009

Marine station posts in river identified as Station 1 near crossing.

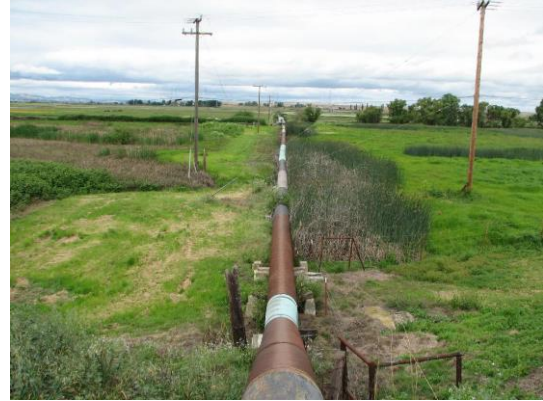
Photo 2 of 3 : UCIP_FA_2015_1749.jpg

Action/Comments					
Inspector Comments: FS_ID:22063 DS_ID:24215 EP_NO: N/A FS_HLM: 0 Repair Type: Non-Urgent Crossing Status: Found UCIP Comments: Dense vegetation limits the inspector's visibility to identify signs of pipe failure (leaks) along the slopes. Recommend removing vegetation along pipe alignment to conduct proper inspection of structure and appurtenances. FIELD_STRUCT_DESC: 30-inch steel drainage pipe through the levee, 11.1 feet below the crown. CM cutoff wall around pipe at center of levee. Siphon breaker on both sides. Pump on landward side approximately 300 feet from landward toe. Pipe exposed on both levee slopes. Rock revetment on waterward slope. (USACE-1962). This entry matches the Drainage or Irrigation Structure referenced in O&M manual (HLM 0.0). Marine Station number 1 located on waterward side with attached small solar panel on top. FS Date: 05/05/2009

Overview of landward slope above ground once it exits levee. Pump is located approximately 300 feet from levee toe.

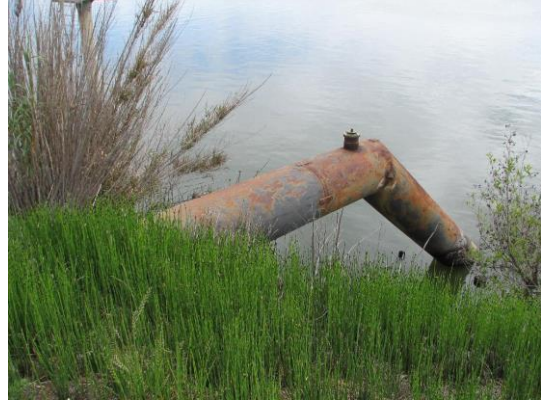
Photo 3 of 3 : UCIP_FA_2015_1751.jpg

LM Start	0.00	Rating **	M	Issue No.	27 (cont)
LM End	0.00	Issue Type +	En	Location *	N/A
Category	Supplemental			GPS Latitude/Longitude	
				Start	End
Item	DWR UCIP Field Study			38.085507 °	38.085507 °
				-121.686528 °	-121.686528 °
DWR ID					
Action/Comments					
Inspector Comments: FS_ID:22063 DS_ID:24215 EP_NO: N/A FS_HLM: 0 Repair Type: Non-Urgent Crossing Status: Found UCIP Comments: Dense vegetation limits the inspector's visibility to identify signs of pipe failure (leaks) along the slopes. Recommend removing vegetation along pipe alignment to conduct proper inspection of structure and appurtenances. FIELD_STRUCT_DESC: 30-inch steel drainage pipe through the levee, 11.1 feet below the crown. CM cutoff wall around pipe at center of levee. Siphon breaker on both sides. Pump on landward side approximately 300 feet from landward toe. Pipe exposed on both levee slopes. Rock revetment on waterward slope. (USACE-1962). This entry matches the Drainage or Irrigation Structure referenced in O&M manual (HLM 0.0). Marine Station number 1 located on waterward side with attached small solar panel on top. FS Date: 05/05/2009

View of pipe and siphon breaker located on waterward side--dense vegetation on slope.

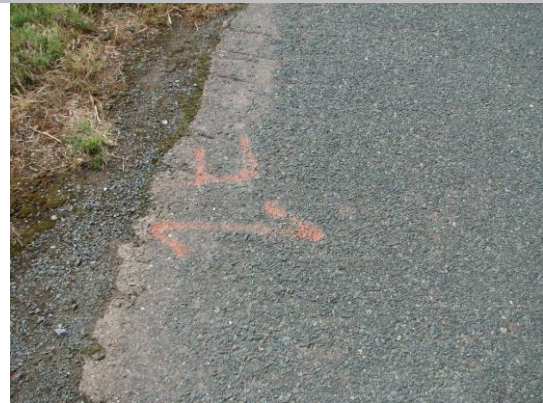
Photo 2 of 3 : UCIP_FA_2015_1753.jpg

Inspector Comments: FS_ID:22064
 DS_ID:24110
 EP_NO: 6297
 FS_HLM: 0.48
 Repair Type: Non-Urgent
 Crossing Status: Found
 UCIP Comments: Markers Missing. No markers found to confirm crossing is still in use--need to contact owner to determine status of crossing.
 FIELD_STRUCT_DESC: 3-inch electrical conduit through the levee, 3.5 feet below the crown. Location marker on waterward shoulder--no marker found. Pole on landward side. Rock revetment on waterward slope. (Permit No. 6297-1969)
 FS Date: 05/05/2009

Underground Service Alert (USA) markings on road shoulder.

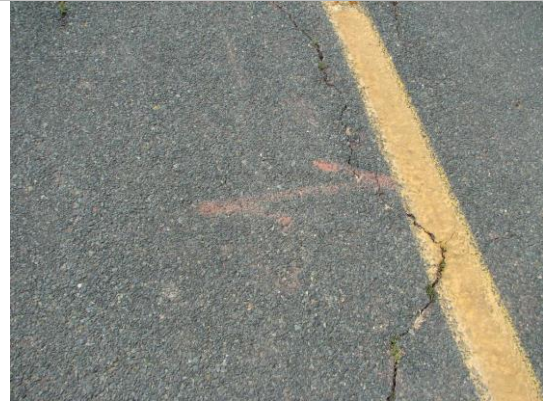
Photo 3 of 3 : UCIP_FA_2015_1754.jpg

LM Start	0.48	Rating **	M	Issue No.	28 (cont)
LM End	0.48	Issue Type +	En	Location *	WS
Category	Supplemental			GPS Latitude/Longitude	
				Start	End
Item	DWR UCIP Field Study			38.092464 °	38.092464 °
				-121.686962 °	-121.686962 °
DWR ID					
Action/Comments					
Inspector Comments: FS_ID:22064					
DS_ID:24110					
EP_NO: 6297					
FS_HLM: 0.48					
Repair Type: Non-Urgent					
Crossing Status: Found

Underground Service Alert (USA) markings on road surface indicating line is still present.

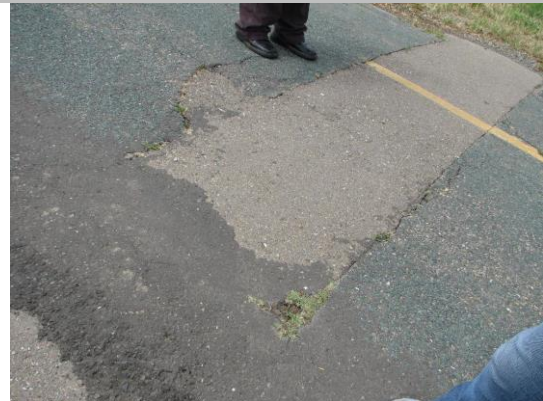
Photo 1 of 3 : UCIP_FA_2015_1750.jpg

LM Start	0.50	Rating **	M	Issue No.	29
LM End	0.50	Issue Type +	En	Location *	WS
Category	Supplemental			GPS Latitude/Longitude	
				Start	End
Item	DWR UCIP Field Study			38.092754 °	38.092754 °
				-121.686878 °	-121.686878 °
DWR ID					
Action/Comments					
Inspector Comments: FS_ID:22068 DS_ID:24111 EP_NO: 1477 FS_HLM: 0.5 Repair Type: Non-Urgent Crossing Status: Found UCIP Comments: Dense vegetation limits the inspector's visibility to identify signs of pipe failure (leaks) along the slopes. Recommend removing vegetation along pipe alignment to conduct proper inspection of structure and appurtenances. FIELD_STRUCT_DESC: 10-inch steel pipe through the levee, 1.8 feet below the crown. Pipe is encased in 12-inch CM condutor pipe under crown. Pump on landward side. Air vent and metal distribution box with gate on the landward side. Rock revetment on the waterward slope. (USACE-1962). This entry matches the Drainage or Irrigation Structure referenced in O&M manual (HLM 0.50). 30-feet of pipe under crown was replaced and encased in CM pipe under Permit No. 1477 (1950). FS Date: 05/05/2009

Cut along pipe alignment--unknown repair or maintenance date.

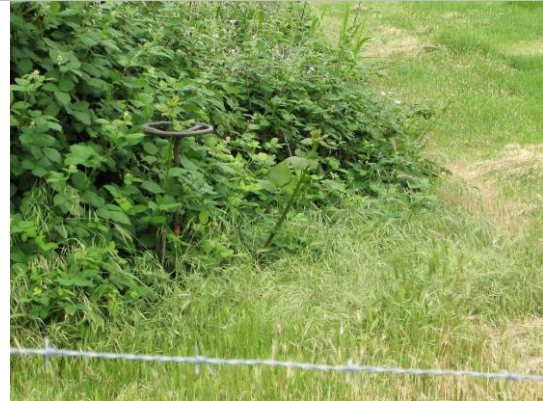
Photo 1 of 3 : UCIP_FA_2015_1757.jpg

LM Start	1.07	Rating **	M	Issue No.	30
LM End	1.07	Issue Type +	En	Location *	LS
Category	Supplemental			GPS Latitude/Longitude	
				Start	End
Item	DWR UCIP Field Study			38.100972 °	38.100972
				-121.686813 °	-121.686813
DWR ID					
Action/Comments					
Inspector Comments: FS_ID:22070 DS_ID:24113 EP_NO: 11095 FS_HLM: 1.066 Repair Type: Non-Urgent Crossing Status: Found UCIP Comments: Dense vegetation limits the inspector's visibility to identify signs of pipe failure (leaks) along the slope. Recommend removing vegetation along pipe alignment to conduct proper inspection of structure and appurtenances. FIELD_STRUCT_DESC: 18-inch pipe sleeved through 24-inch pipe through the levee, 4.0 feet below the crown. Air vent and monitoring well on landward side. Pipe exposed on the waterward slope. This pipe was retained under ABO No. 11095 (1975). FS Date: 05/05/2009

Gate located past the fence area near landward toe.

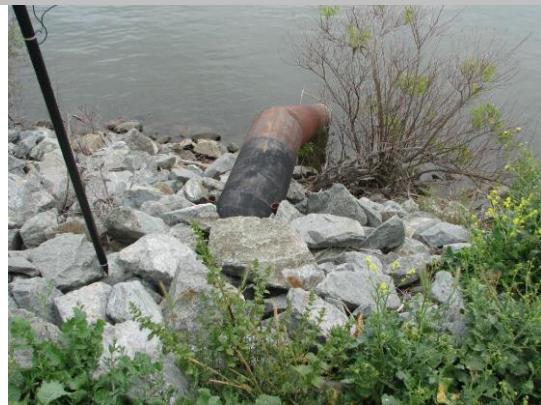
Photo 3 of 3 : UCIP_FA_2015_1759.jpg

Inspector Comments: FS_ID:22070
 DS_ID:24113
 EP_NO: 11095
 FS_HLM: 1.066
 Repair Type: Non-Urgent
 Crossing Status: Found
 UCIP Comments: Dense vegetation limits the inspector's visibility to identify signs of pipe failure (leaks) along the slope. Recommend removing vegetation along pipe alignment to conduct proper inspection of structure and appurtenances.
 FIELD_STRUCT_DESC: 18-inch pipe sleeved through 24-inch pipe through the levee, 4.0 feet below the crown. Air vent and monitoring well on landward side. Pipe exposed on the waterward slope. This pipe was retained under ABO No. 11095 (1975).
 FS Date: 05/05/2009

View of pipe located on waterward side.

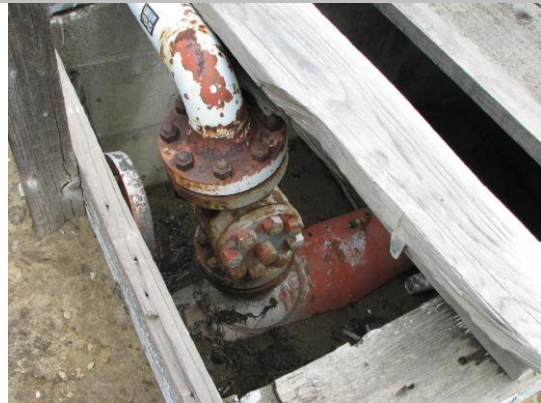
Photo 2 of 3 : UCIP_FA_2015_1761.jpg

LM Start	1.44	Rating **	M	Issue No.	31
LM End	1.44	Issue Type +	En	Location *	LS
Category	Supplemental			GPS Latitude/Longitude	
				Start	End
Item	DWR UCIP Field Study			38.106183 °	38.106183
				-121.685541 °	-121.685541 °
DWR ID					
Action/Comments					
Inspector Comments: FS_ID:22074 DS_ID:24115 EP_NO: N/A FS_HLM: 1.43 Repair Type: Non-Urgent Crossing Status: Found

View of pipe inside concrete box located on landward side.

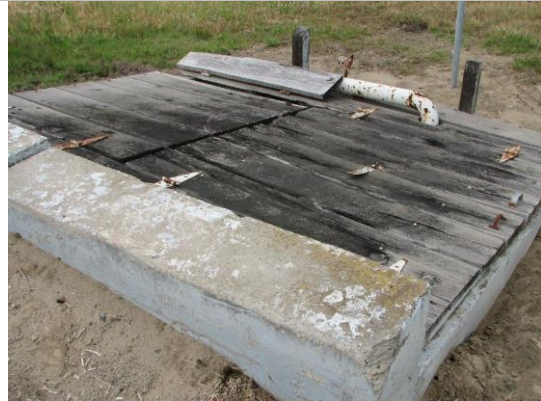
Photo 3 of 3 : UCIP_FA_2015_1762.jpg

LM Start	1.44	Rating **	M	Issue No.	31 (cont)
LM End	1.44	Issue Type +	En	Location *	LS
Category	Supplemental			GPS Latitude/Longitude	
				Start	End
Item	DWR UCIP Field Study			38.106183 °	38.106183
				-121.685541 °	-121.685541
DWR ID					
Action/Comments					
Inspector Comments: FS_ID:22074					
DS_ID:24115					
EP_NO: N/A					
FS_HLM: 1.43					
Repair Type: Non-Urgent					
Crossing Status: Found

Concrete box located on landward side.

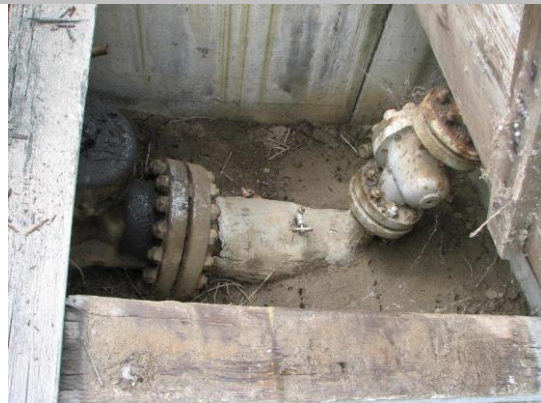
Photo 1 of 3 : UCIP_FA_2015_1763.jpg

LM Start	1.45	Rating **	M	Issue No.	32
LM End	1.45	Issue Type +	En	Location *	LS
Category	Supplemental			GPS Latitude/Longitude	
				Start	End
Item	DWR UCIP Field Study			38.106323 °	38.106323 °
				-121.685493 °	-121.685493 °
DWR ID					
Action/Comments					
Inspector Comments: FS_ID:22076 DS_ID:24217 EP_NO: N/A FS_HLM: 1.44 Repair Type: Non-Urgent Crossing Status: Found UCIP Comments: Unknown detail of the size of crossing. Need to contact owner to determine if crossing is still active and to determine last inspection date. Will need copy of letter showing crossings passed inspection. NEED photo of emergency contact information from marker. FIELD_STRUCT_DESC: Gas line through the levee. (USACE-1962). This entry matches the Drainage or Irrigation Structure referenced in O&M manual (HLM 1.44). FS Date: 05/05/2009

Inside view of vault located on the landward side.

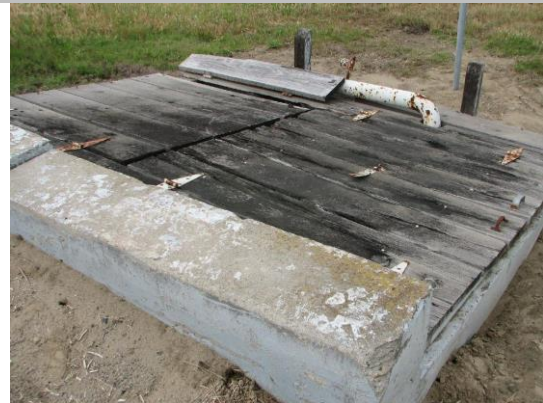
Photo 3 of 3 : UCIP_FA_2015_1765.jpg

Inspector Comments: FS_ID:22076
 DS_ID:24217
 EP_NO: N/A
 FS_HLM: 1.44
 Repair Type: Non-Urgent
 Crossing Status: Found
 UCIP Comments: Unknown detail of the size of crossing. Need to contact owner to determine if crossing is still active and to determine last inspection date. Will need copy of letter showing crossings passed inspection. NEED photo of emergency contact information from marker.
 FIELD_STRUCT_DESC: Gas line through the levee. (USACE-1962). This entry matches the Drainage or Irrigation Structure referenced in O&M manual (HLM 1.44).
 FS Date: 05/05/2009

Concrete box located on landward side.

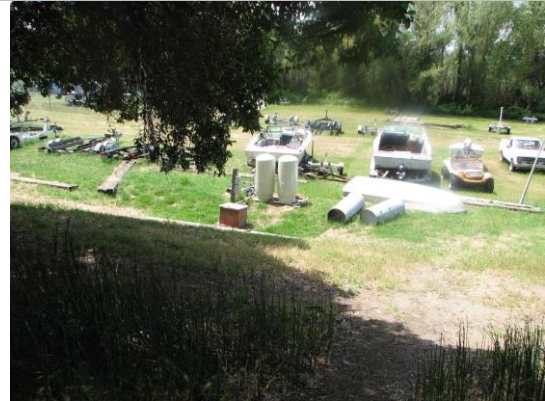
Photo 1 of 3 : UCIP_FA_2015_1766.jpg

LM Start	1.96	Rating **	M	Issue No.	33
LM End	1.96	Issue Type +	En	Location *	WS
Category	Supplemental			GPS Latitude/Longitude	
				Start	End
Item	DWR UCIP Field Study			38.113641 °	38.113641 °
				-121.684112 °	-121.684112 °
DWR ID					
Action/Comments					
Inspector Comments: FS_ID:22086 DS_ID:24116 EP_NO: 11103 FS_HLM: 1.95 Repair Type: Non-Urgent Crossing Status: Found UCIP Comments: Unable to determine if crossing is the same as permitted under permit no. 11103. Need to contact owner and determine status of crossing under permit no. 11103. Believe steel conduit is exposed on landward side. FIELD_STRUCT_DESC: 1.5-inch iron water pipe and 3.5-inch electrical steel conduit through the levee, both 3.0 feet below the crown. Pressure system and service pole on landward slope. Fishing resort on waterward side. This pipe was retained under ABO No. 11103 (1975). FS Date: 05/05/2009

View of landward side.

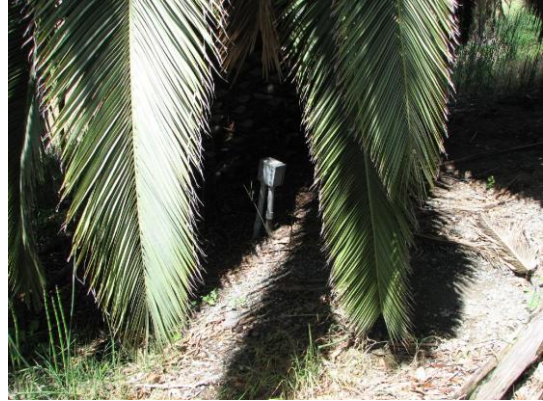
Photo 2 of 3 : UCIP_FA_2015_1767.jpg

Inspector Comments: FS_ID:22086
 DS_ID:24116
 EP_NO: 11103
 FS_HLM: 1.95
 Repair Type: Non-Urgent
 Crossing Status: Found
 UCIP Comments: Unable to determine if crossing is the same as permitted under permit no. 11103. Need to contact owner and determine status of crossing under permit no. 11103. Believe steel conduit is exposed on landward side.
 FIELD_STRUCT_DESC: 1.5-inch iron water pipe and 3.5-inch electrical steel conduit through the levee, both 3.0 feet below the crown. Pressure system and service pole on landward slope. Fishing resort on waterward side. This pipe was retained under ABO No. 11103 (1975).
 FS Date: 05/05/2009

Power connection on waterward side no other appurtenances found.

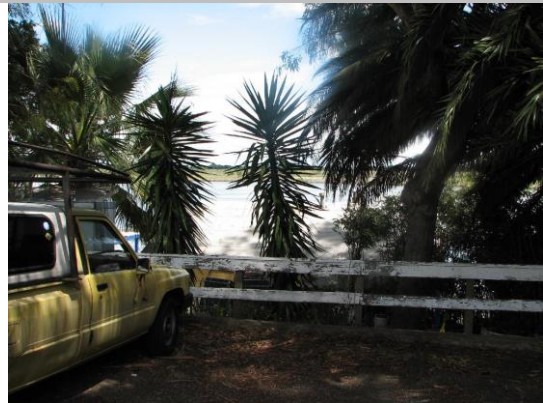
Photo 3 of 3 : UCIP_FA_2015_1784.jpg

View of waterward side.

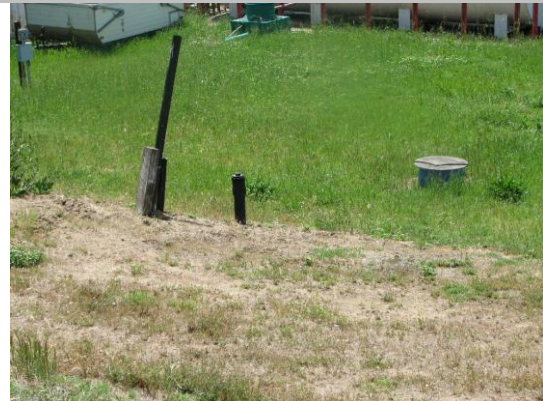
Photo 2 of 2 : UCIP_FA_2015_1789.jpg

LM Start	2.00	Rating **	M	Issue No.	34
LM End	2.00	Issue Type +	En	Location *	WS
Category	Supplemental			GPS Latitude/Longitude	
				Start	End
Item	DWR UCIP Field Study			38.114092 °	38.114092 °
				-121.684524 °	-121.684524 °
DWR ID					
Action/Comments					
Inspector Comments: FS_ID:22093					
DS_ID:24237					
EP_NO: 5427					
FS_HLM: 1.99					
Repair Type: Non-Urgent					
Crossing Status: Indicator Found

Electrical conduit and box located on left corner of picture.

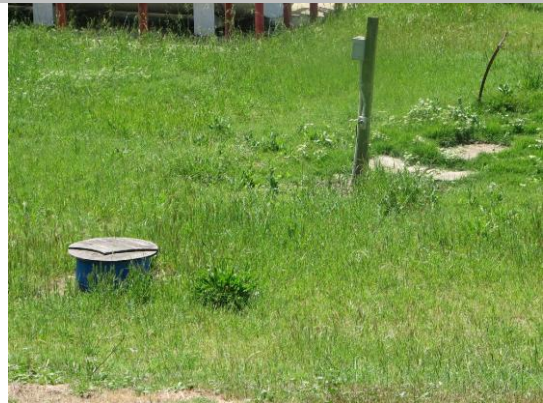
Photo 2 of 3 : UCIP_FA_2015_1786.jpg

LM Start	2.00	Rating **	M	Issue No.	35
LM End	2.00	Issue Type +	En	Location *	WS
Category	Supplemental			GPS Latitude/Longitude	
				Start	End
Item	DWR UCIP Field Study			38.114092 °	38.114092 °
				-121.684524 °	-121.684524 °
DWR ID					
Action/Comments					
Inspector Comments: FS_ID:22091					
DS_ID:24117					
EP_NO: 5427					
FS_HLM: 1.99					
Repair Type: Non-Urgent					
Crossing Status: Indicator Found

Stand pipe (potential observation well) and concrete pad located on landward side.

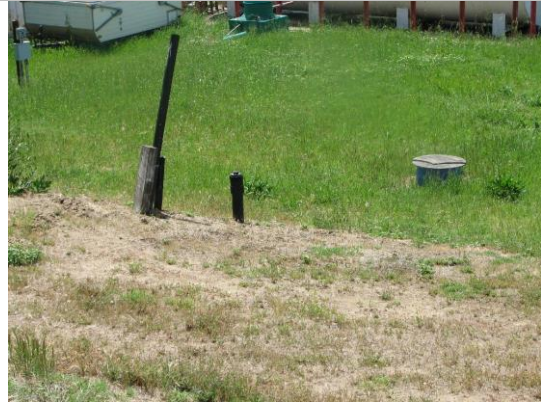
Photo 3 of 3 : UCIP_FA_2015_1787.jpg

LM Start	2.00	Rating **	M	Issue No.	35 (cont)
LM End	2.00	Issue Type +	En	Location *	WS
Category	Supplemental			GPS Latitude/Longitude	
				Start	End
Item	DWR UCIP Field Study			38.114092 °	38.114092 °
				-121.684524 °	-121.684524 °
DWR ID					
Action/Comments					
Inspector Comments: FS_ID:22091					
DS_ID:24117					
EP_NO: 5427					
FS_HLM: 1.99					
Repair Type: Non-Urgent					
Crossing Status: Indicator Found

View of potential observation well on landward side.

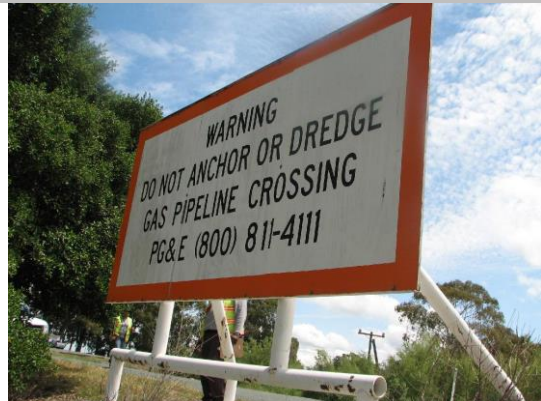
Photo 2 of 2 : UCIP_FA_2015_1791.jpg

LM Start	2.05	Rating **	M	Issue No.	37
LM End	2.05	Issue Type +	En	Location *	WS
Category	Supplemental			GPS Latitude/Longitude	
				Start	End
Item	DWR UCIP Field Study			38.114043 °	38.114043 °
				-121.685421 °	-121.685421 °
DWR ID					
Action/Comments					
Inspector Comments: FS_ID:22094					
DS_ID:24119					
EP_NO: 960					
FS_HLM: 2.04					
Repair Type: Non-Urgent					
Crossing Status: Indicator Found

Pipeline marker located on waterward shoulder.

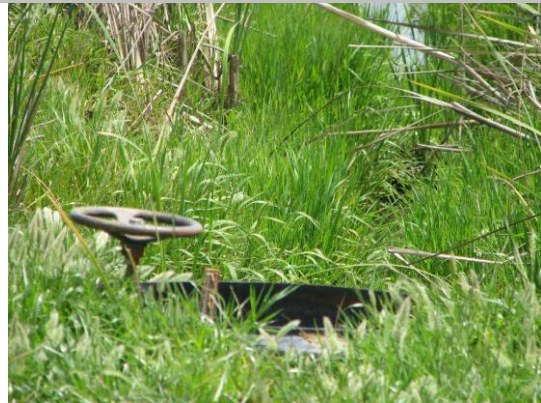
Photo 2 of 3 : UCIP_FA_2015_2394.jpg

Riser and gate visible on waterward side--dense vegetation limits inspection.

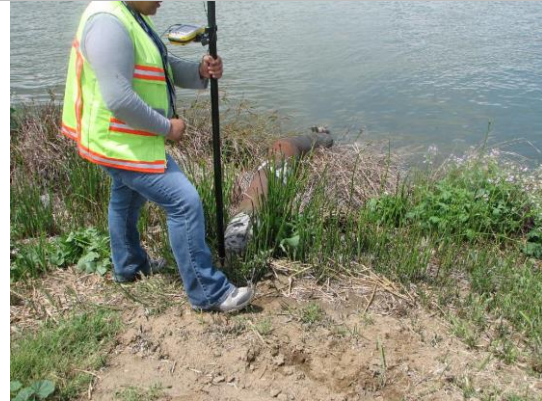
Photo 3 of 3 : UCIP_FA_2015_2395.jpg

View of pipe on waterward side.

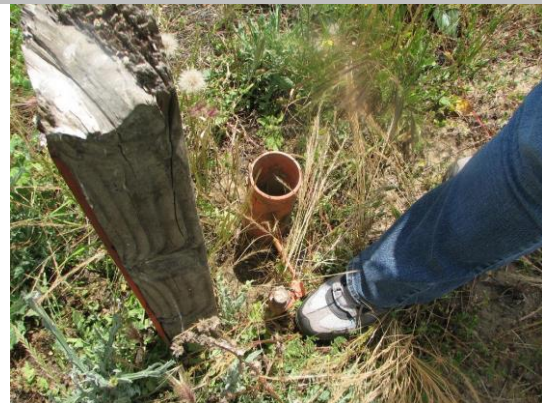
Photo 1 of 3 : UCIP_FA_2015_2399.jpg

Small stand pipe located on waterward side--unknown purpose of stand pipe.

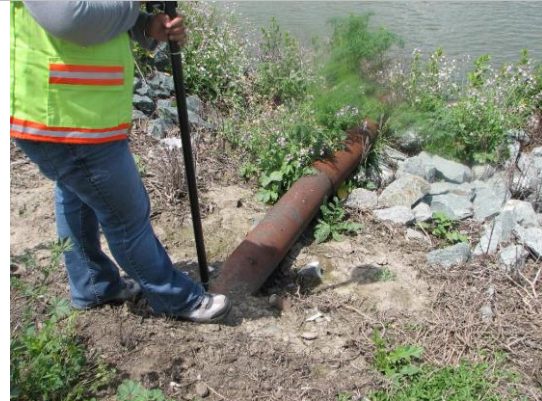
Photo 3 of 3 : UCIP_FA_2015_2401.jpg

View of pipe and rip rap located on waterward side.

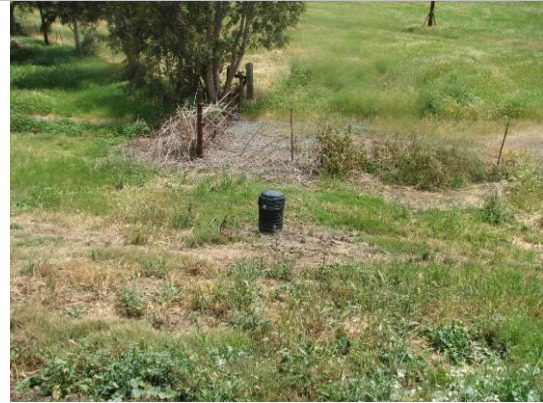
Photo 2 of 3 : UCIP_FA_2015_2397.jpg

Stand pipe located near levee toe on landward side.

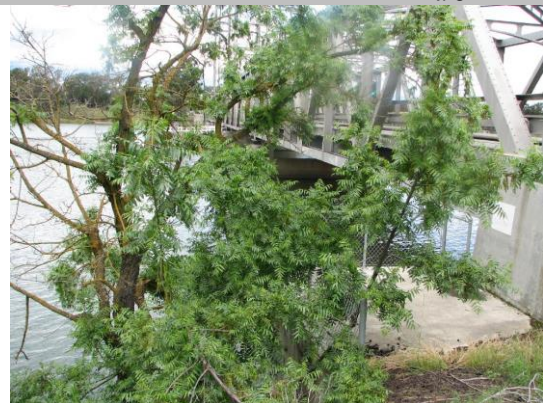
Photo 1 of 3 : UCIP_FA_2015_1669.jpg

View of waterward side.

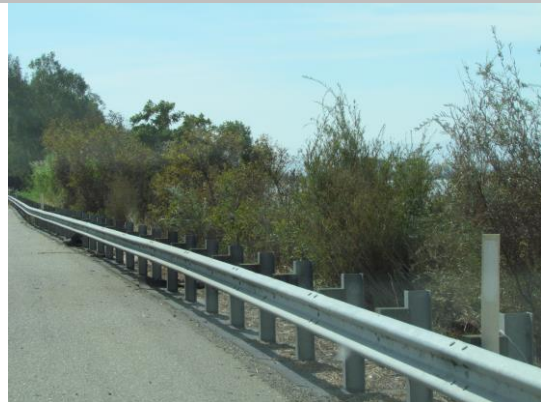
Photo 1 of 1 : FA_2015_RD0341_168_45_20151008_00023.jpg

Looking downstream from the waterside slope unwanted vegetation shoulder and slope.

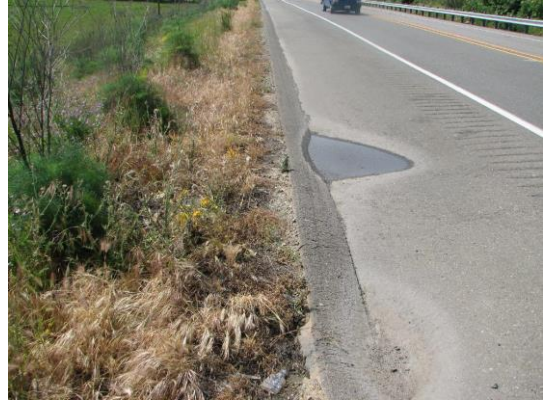
Photo 2 of 2 : UCIP_FA_2015_1733.jpg

View of landward shoulder and low spots on highway.

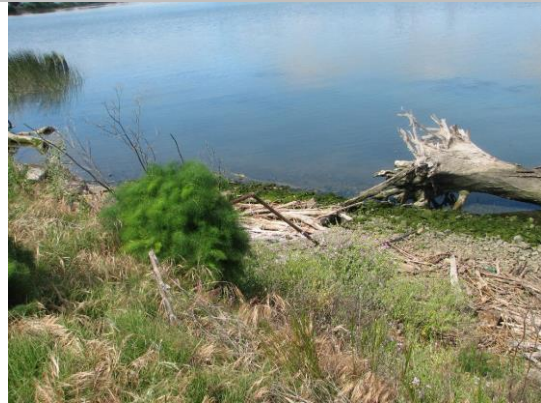
Photo 1 of 2 : UCIP_FA_2015_1672.jpg

View of waterward toe.

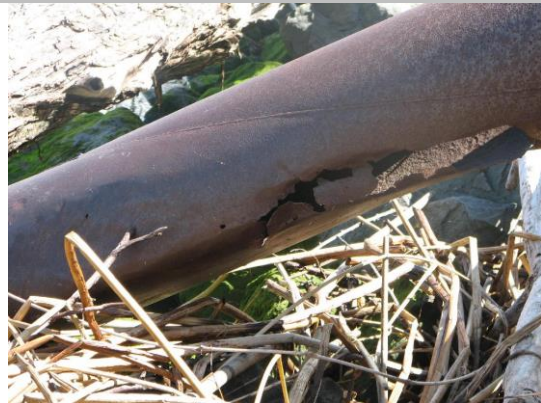
Photo 1 of 2 : UCIP_FA_2015_1818.jpg

Holes present on waterward side.

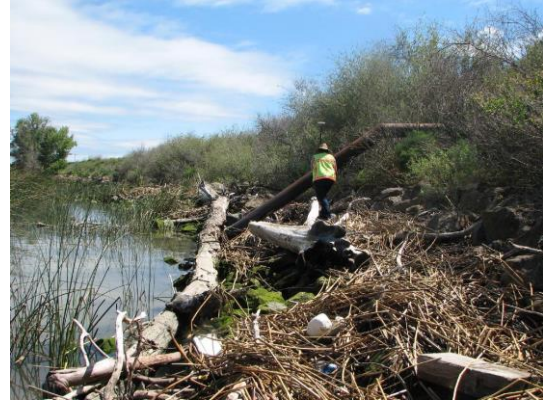
Photo 2 of 2 : UCIP_FA_2015_1819.jpg

View of crossing on waterward side. Dense vegetation limits inspection of crossing.

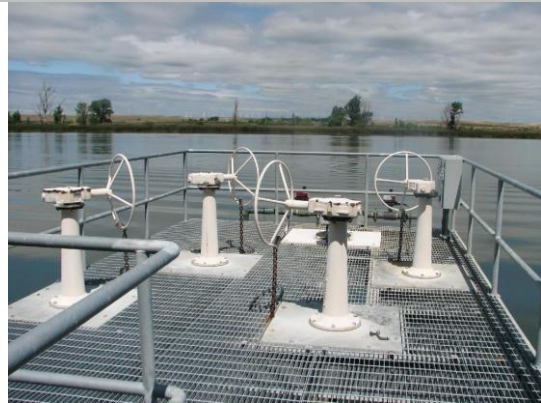
Photo 1 of 3 : UCIP_FA_2015_2349.jpg

Gates located on waterward side.

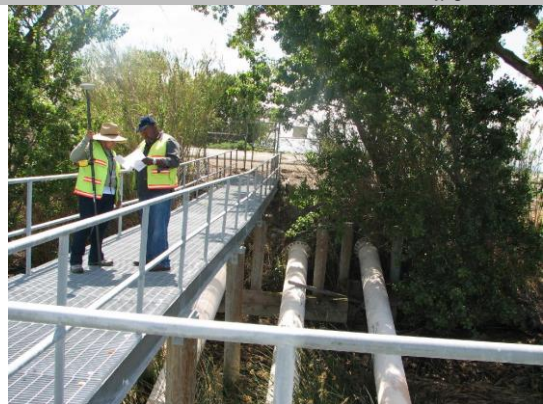
Photo 3 of 3 : UCIP_FA_2015_2351.jpg

Pipes, walkway, fence, and support piles located on waterward side.

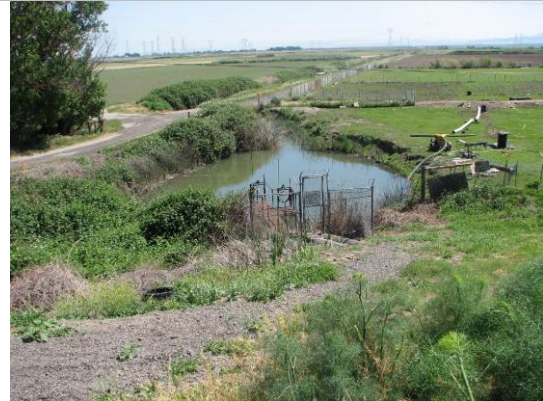
Photo 1 of 4 : UCIP_FA_2015_2352.jpg

Overview of landward side, photo 1 of 2.

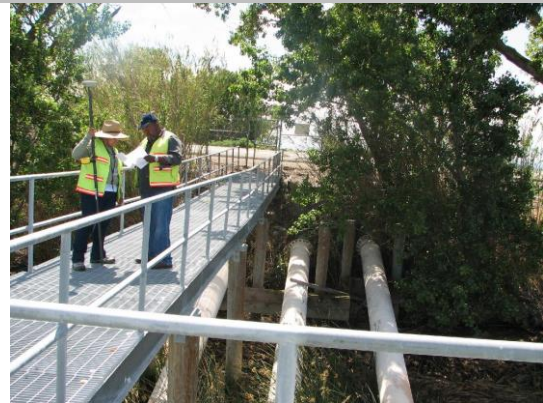
Photo 2 of 4 : UCIP_FA_2015_2353.jpg

Pipes, walkway, fence, and support piles located on waterward side.

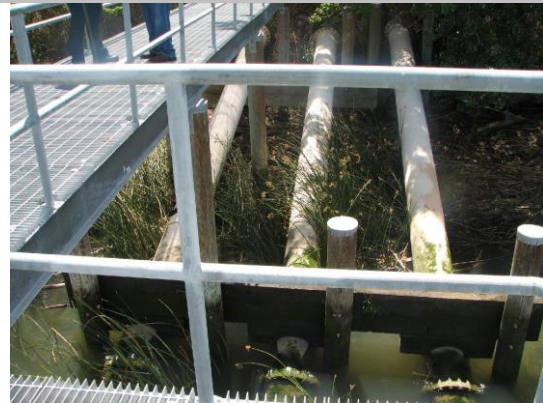
Photo 4 of 4 : UCIP_FA_2015_2355.jpg

View of waterward side - 3-20 inch pipes.

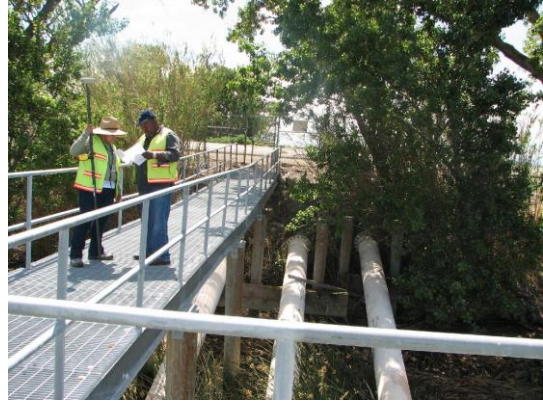
Photo 3 of 3 : UCIP_FA_2015_2358.jpg

Pipes, walkway, fence, and support piles located on waterward side.

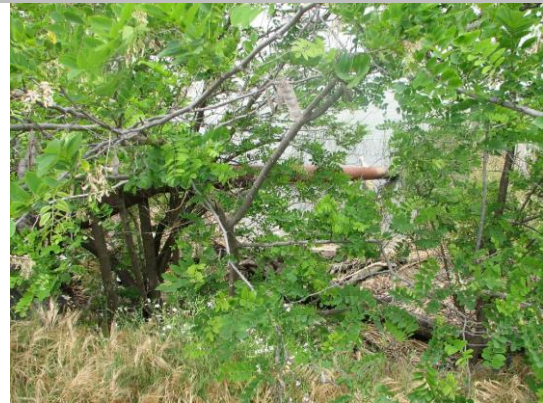
Photo 1 of 3 : UCIP_FA_2015_2383.jpg

View of pipe through brush on waterward side.

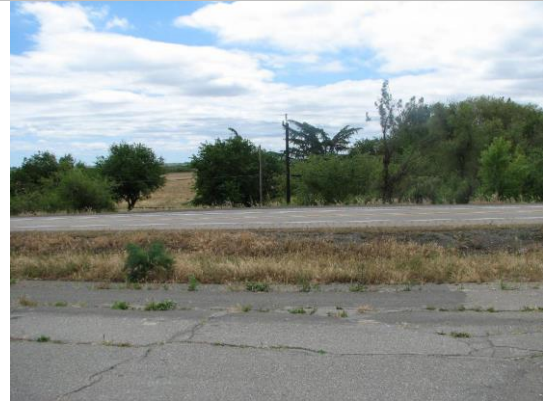
Photo 2 of 3 : UCIP_FA_2015_2384.jpg

Overview of levee crown at crossing.

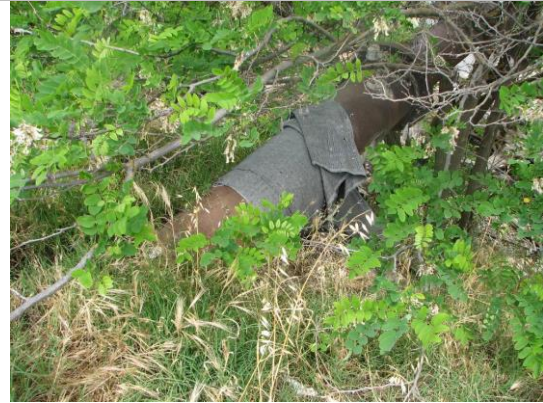
Photo 3 of 3 : UCIP_FA_2015_2385.jpg

Pipe on waterward side at daylight.

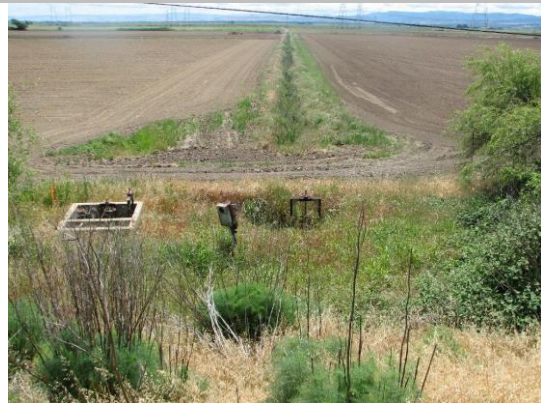
Photo 2 of 3 : UCIP_FA_2015_2436.jpg

View of landward side.

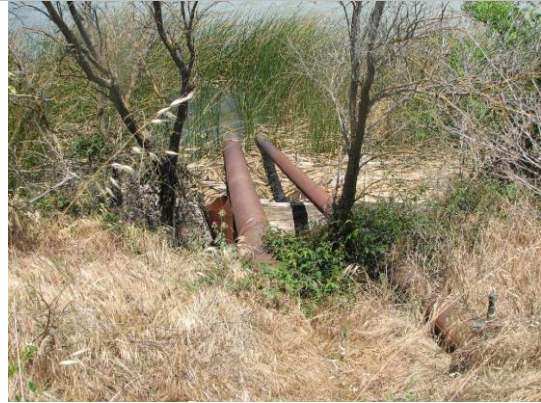
Photo 3 of 3 : UCIP_FA_2015_2437.jpg

8-inch pipe and 14-inch pipe on waterward side.

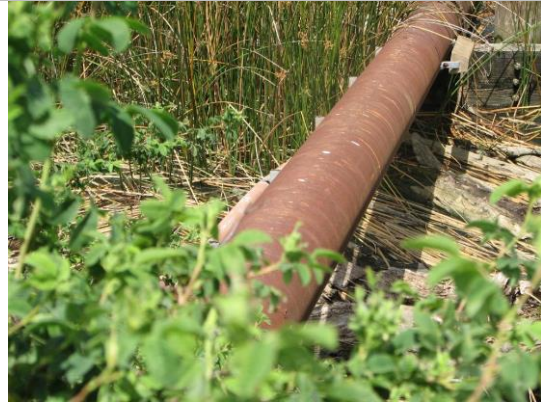
Photo 1 of 3 : UCIP_FA_2015_6533.jpg

Action/Comments					
<p>Inspector Comments: FS_ID:39861 DS_ID:24076 EP_NO: 11116 FS_HLM: 6.12 Repair Type: Non-Urgent Crossing Status: Found UCIP Comments: Need to contact owner to determine status of crossing. If crossing is no longer used will need to meet Title 23 requirements. Hole present in pipe section. Debris on waterward side-- 10-inch pipe section abandoned on slope. Dense vegetation limits the inspector's visibility to identify signs of pipe failure (leaks) along the slope. Recommend removing vegetation along pipe alignment to conduct proper inspection of structure and appurtenances. FIELD_STRUCT_DESC: 12-inch pipe sleeved through 14-inch pipe through levee, 4.0 feet below crown. Annular gap grouted. Slide gate in distribution box on landward side. (USACE-1962). This entry matches the Drainage or Irrigation Structure referenced in O&M manual (HLM 6.12). This pipe was retained under ABO No. 11116 (1975). Distribution box installed and pipe along landward slope removed and replaced with longer 16-inch steel pipe under Permit No. 15372 (1993). FS Date: 05/06/2009</p>

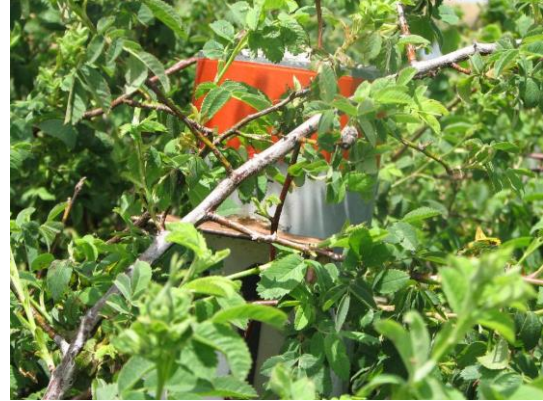
Photo 2 of 3 : UCIP_FA_2015_6534.jpg

Action/Comments					
Inspector Comments: FS_ID:39861 DS_ID:24076 EP_NO: 11116 FS_HLM: 6.12 Repair Type: Non-Urgent Crossing Status: Found UCIP Comments: Need to contact owner to determine status of crossing. If crossing is no longer used will need to meet Title 23 requirements. Hole present in pipe section. Debris on waterward side-- 10-inch pipe section abandoned on slope. Dense vegetation limits the inspector's visibility to identify signs of pipe failure (leaks) along the slope. Recommend removing vegetation along pipe alignment to conduct proper inspection of structure and appurtenances. FIELD_STRUCT_DESC: 12-inch pipe sleeved through 14-inch pipe through levee, 4.0 feet below crown. Annular gap grouted. Slide gate in distribution box on landward side. (USACE-1962). This entry matches the Drainage or Irrigation Structure referenced in O&M manual (HLM 6.12). This pipe was retained under ABO No. 11116 (1975). Distribution box installed and pipe along landward slope removed and replaced with longer 16-inch steel pipe under Permit No. 15372 (1993). FS Date: 05/06/2009

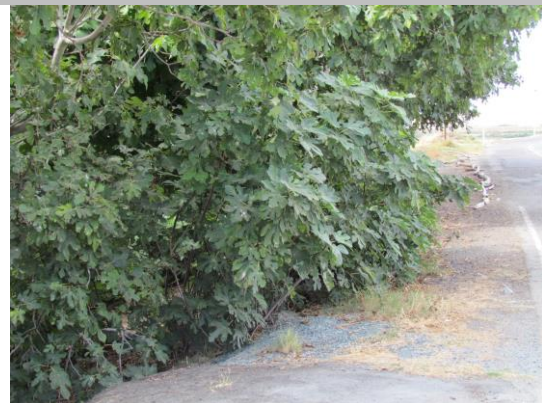
Photo 1 of 1 : FA_2015_RD0341_168_47_20151008_00025.jpg

Landside slope blocked by woody growth of fig trees.

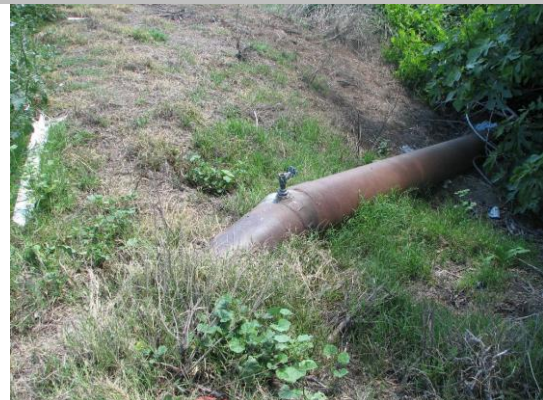
Photo 2 of 3 : UCIP_FA_2015_2441.jpg

View of crossing on landward slope.

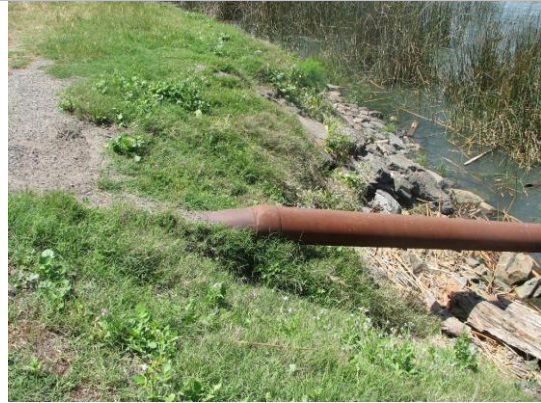
Photo 3 of 3 : UCIP_FA_2015_2442.jpg

Side view of pipe on waterward side.

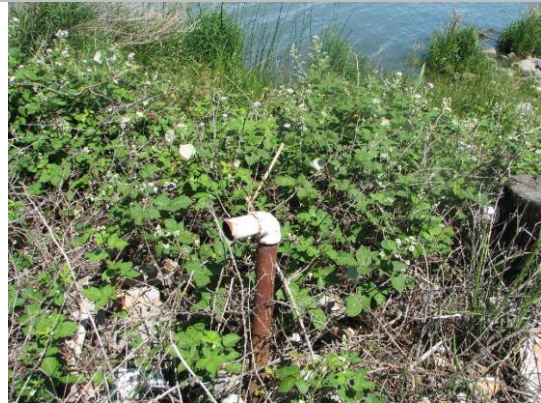
Photo 1 of 2 : UCIP_FA_2015_2443.jpg

View of waterward side air vent pipe could be associated with crossing.

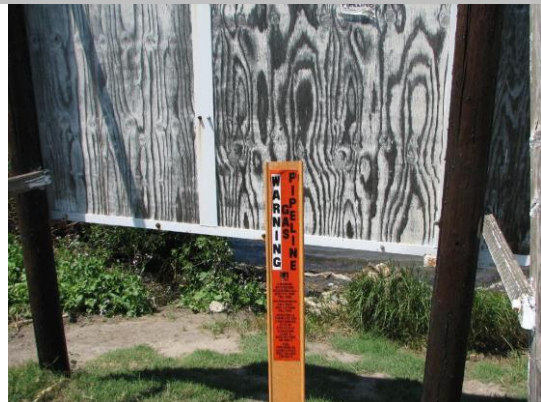
Photo 1 of 2 : UCIP_FA_2015_2475.jpg

Marker located on waterward side.

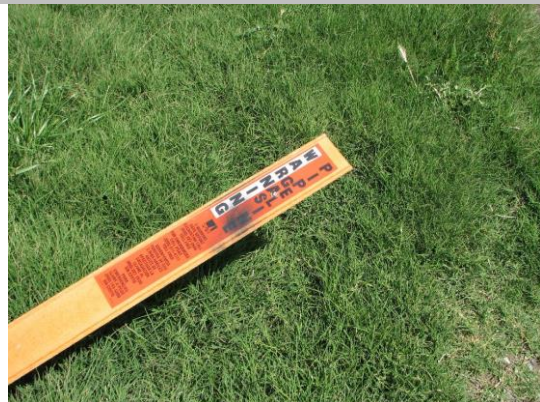
Photo 1 of 3 : UCIP_FA_2015_2405.jpg

Damaged marker located on waterward side.

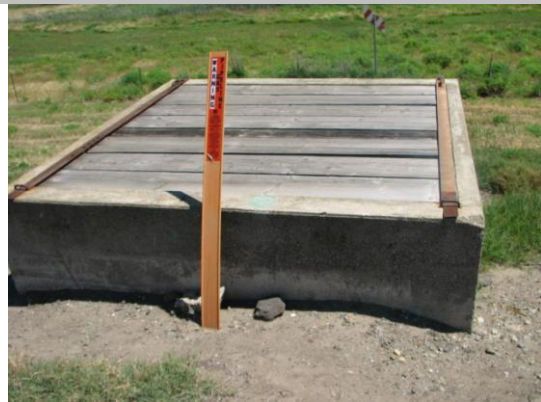
Photo 3 of 3 : UCIP_FA_2015_2407.jpg

Concrete box and marker located on near landward shoulder. Additional marker located at the levee toe.

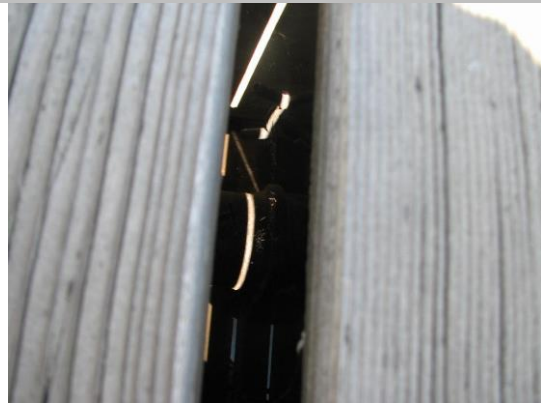
Photo 2 of 3 : UCIP_FA_2015_2403.jpg

Unable to confirm number of pipes.

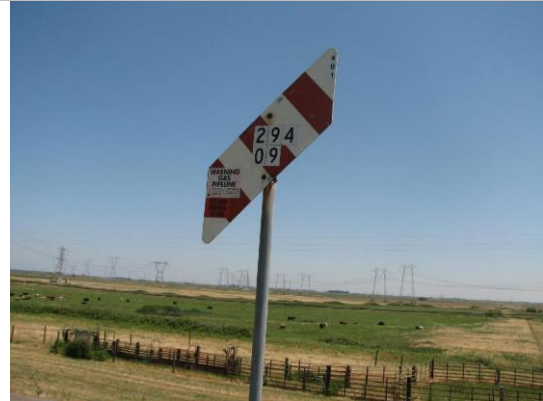
Photo 2 of 2 : UCIP_FA_2015_2478.jpg

Utility marker located on landward side.

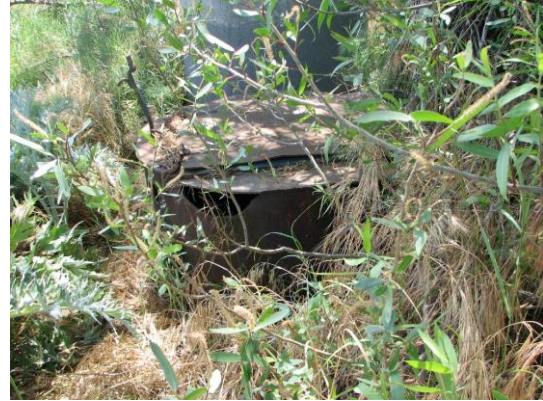
Photo 2 of 3 : UCIP_FA_2015_2526.jpg

Steel stand pipe located on landward side near levee toe.

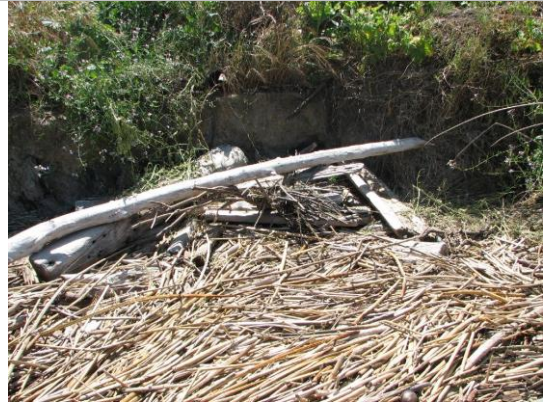
Photo 3 of 3 : UCIP_FA_2015_2527.jpg

Concrete headwall located on waterward side.

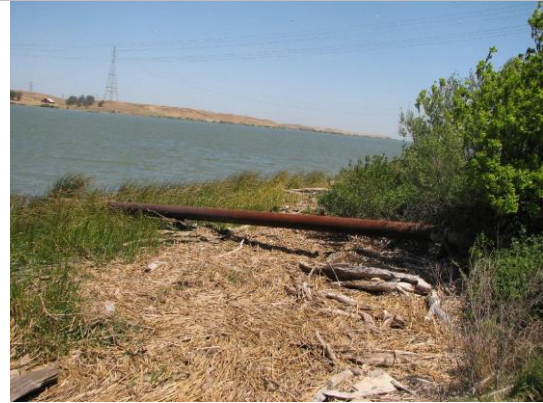
Photo 1 of 3 : UCIP_FA_2015_2522.jpg

View of crossing located on waterward side.

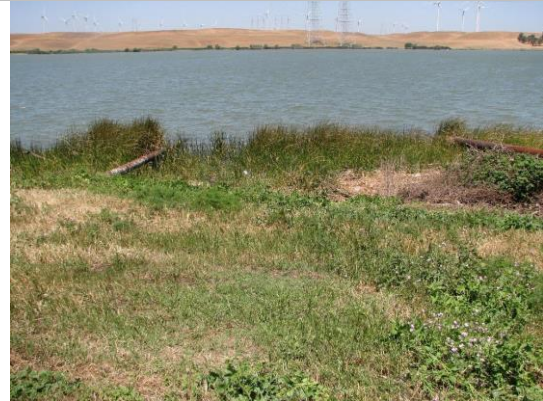
Photo 2 of 3 : UCIP_FA_2015_2523.jpg

Overview of waterward side-18-inch pipe located on right side and 12-inch pipe located on left side.

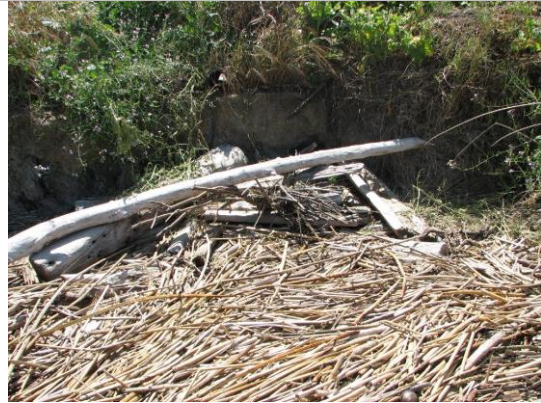
Photo 3 of 3 : UCIP_FA_2015_2524.jpg

Concrete headwall found on waterward side.

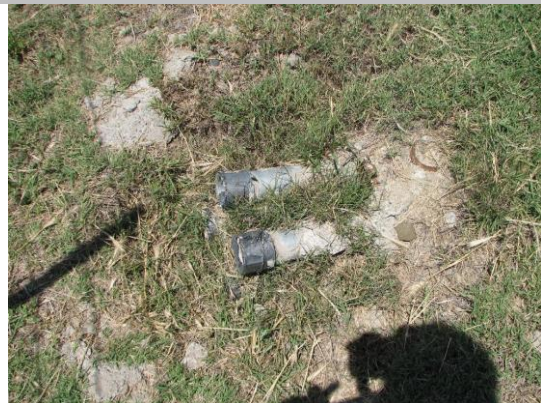
Photo 1 of 3 : UCIP_FA_2015_2547.jpg

View of conduit on landward side. Four 2.5-inch conduits through levee not in use yet.

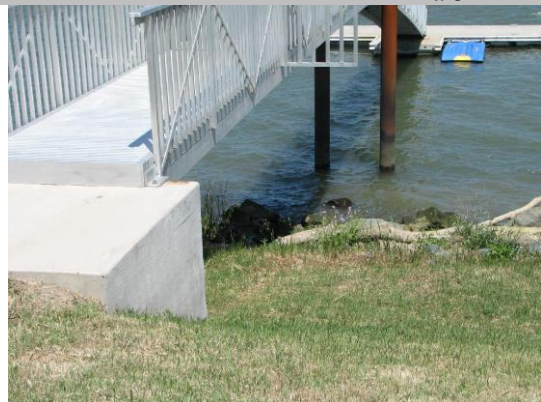
Photo 3 of 3 : UCIP_FA_2015_2549.jpg

View of waterward side. Conduit goes though concrete structure connecting walkway.

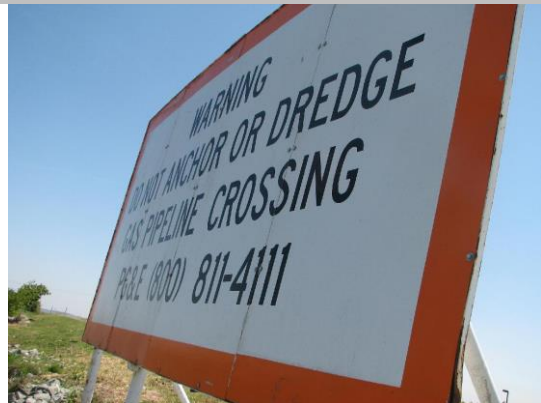
Photo 1 of 3 : UCIP_FA_2015_2554.jpg

Gas line crossing sign located on waterward side.

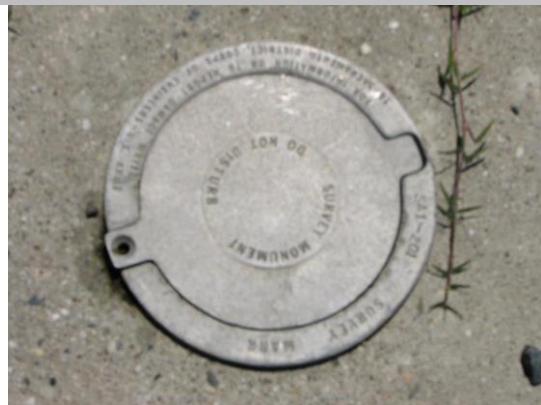
Photo 3 of 3 : UCIP_FA_2015_2556.jpg

Surve marker located at site.

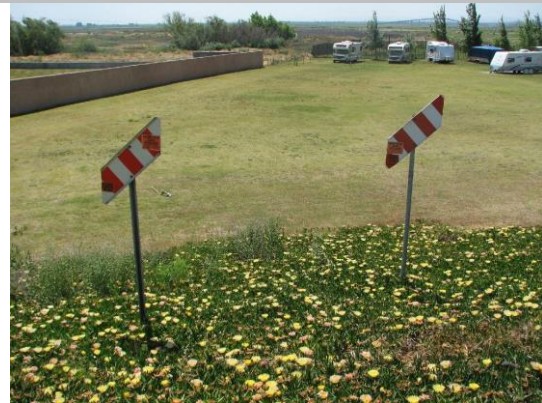
Photo 2 of 3 : UCIP_FA_2015_2552.jpg

Gas line markers visible on landward side.

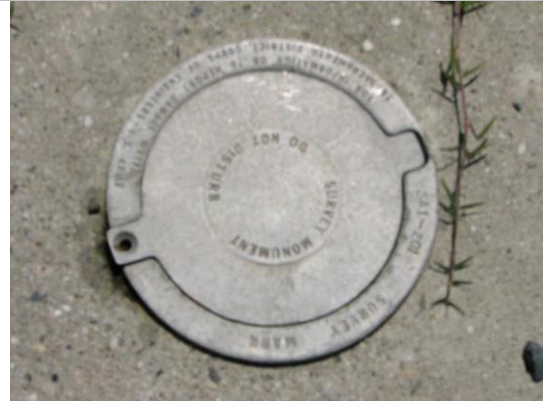
Photo 3 of 3 : UCIP_FA_2015_2553.jpg

Survey marker found at this location.

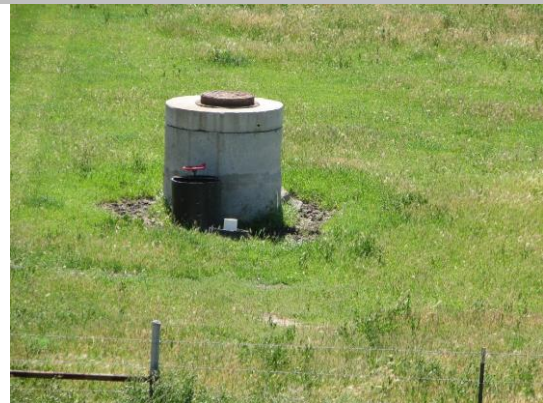
Photo 1 of 3 : UCIP_FA_2015_2293.jpg

Concrete stand pipe and gate valve located on landward side.

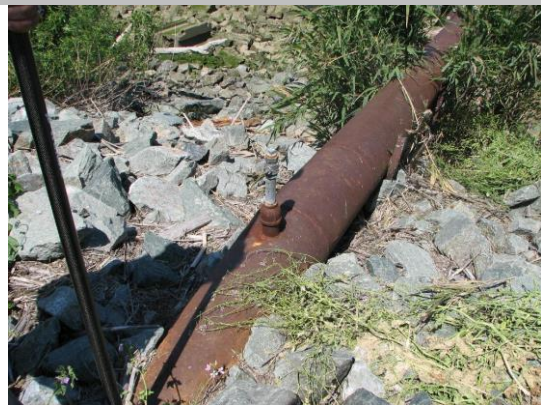
Photo 3 of 3 : UCIP_FA_2015_2295.jpg

Siphon breaker visible on waterward side. Levee toe is armored with rock slope protection.

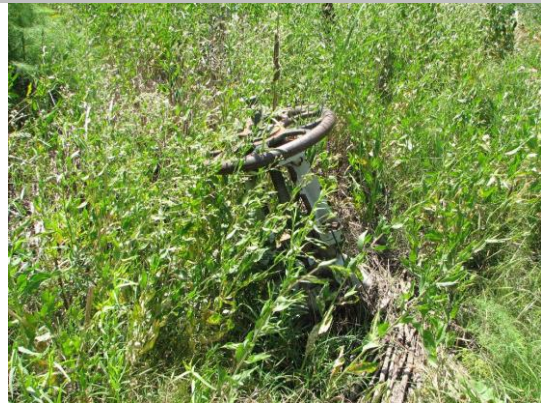
Photo 2 of 3 : UCIP_FA_2015_2298.jpg

Gate valve covered by dense vegetation.

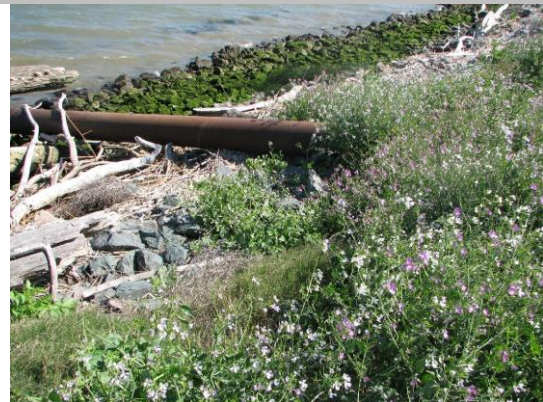
Photo 3 of 3 : UCIP_FA_2015_2323.jpg

Overview of waterward side.
